Stream Team Report

Millham and North Branch Brooks Marlborough, Massachusetts

Study Conducted March-June 2008

By Jennifer Boudrie

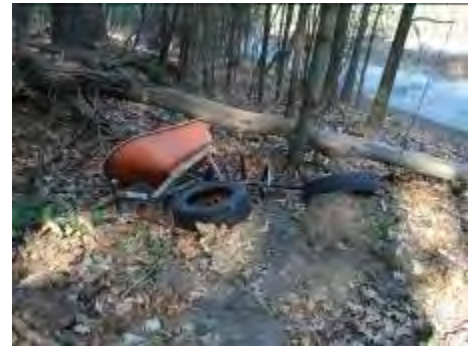
We decided to walk upstream from the Reservoir. We parked on Milham Street. Trash was abandoned at this site. (See photo on right.) We walked about 200 feet and found what looked like a repaired sewer line. The area looked recently flooded and the ground surface cleaned up. The surrounding area was covered with a white substance that smelled of chlorine. It covered the roadway, an area under the trees, and flowed down the bank towards the reservoir. It is possible that the sewer line breached near the reservoir and in an attempt to mitigate the pollution the area was covered with chlorine. The chlorine-like smell was quite strong. No doubt the attempt to protect the water supply was a priority but the chlorine is clearly toxic and hazardous to flora and fauna.

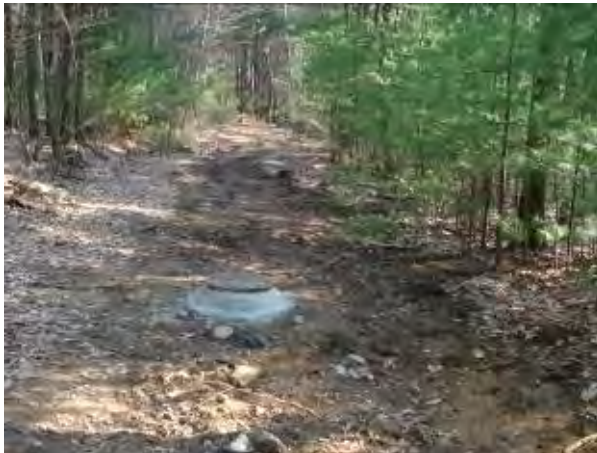
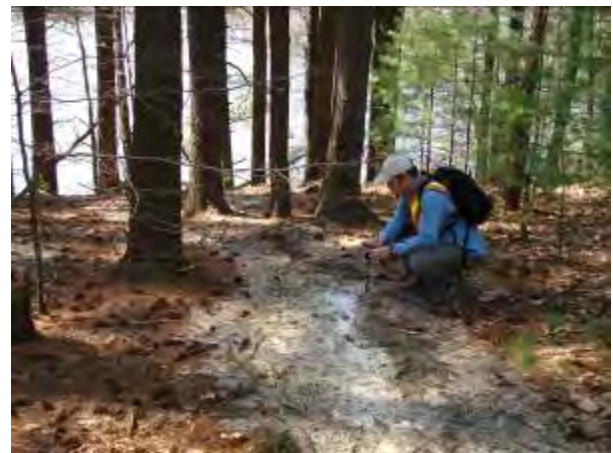
Two views: The sewer line and the chlorine-like chemical deposit.

The city sewer line runs parallel to the stream and the reservoir. If it ruptures or overflows it can pollute Milham Reservoir which is about 25% of the city's drinking water supply. The chemicals used for clean up are toxic to people, flora and fauna in the immediate area.

Investigate the sewer line and the chemicals.

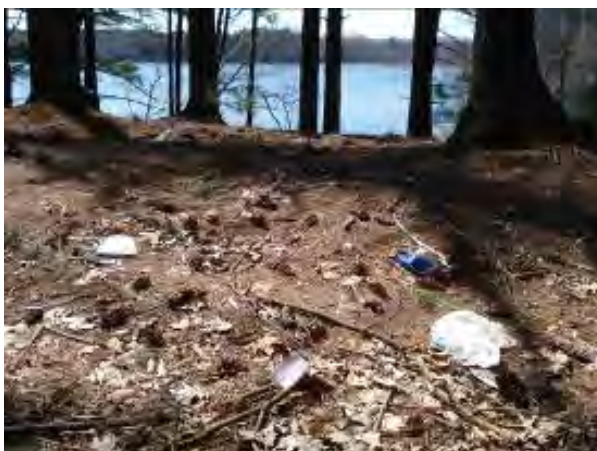
Some trash is visible near reservoir.

Trash was strewn in a few areas. A few tires were in the stream. Old metal debris, such as a car bumper and an old Coca-cola machine were in the water or near the stream.

Remove the trash.

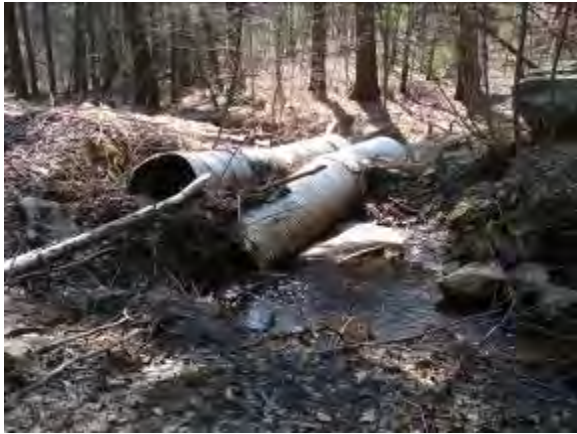
Culvert (map F02)

A culvert (two pipes 24 feet long and about 40 inches in diameter) was placed at an angle in the stream. Water was not running through it. It was inadequate as a bridge. Some erosion was occurring around it.

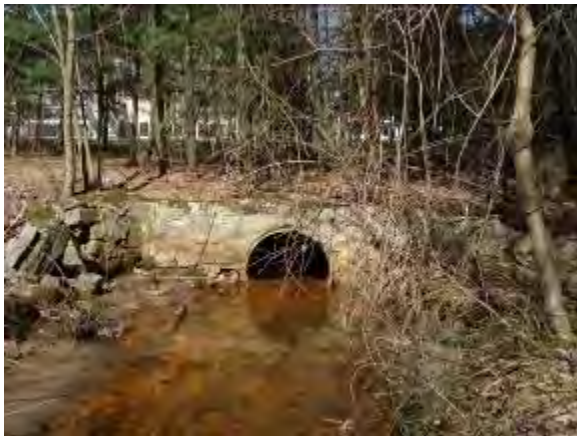
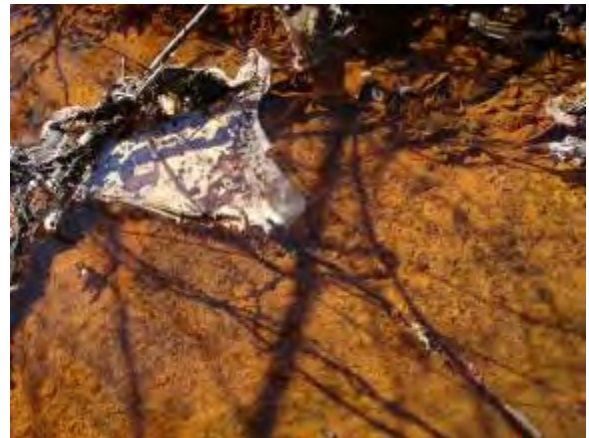
Two views of storm drainage from Evelina Drive and red stream bed (product of iron-loving algae not pollution)

Storm water drains from Evelina Drive into the stream. The streambed was very red, and the water was a bit foamy and scummy. It is possible that soap from people washing their cars, residue from the streets, and unknown sources are polluting the stream.

Investigate the source of pollution from the storm drain near Evelina Drive.

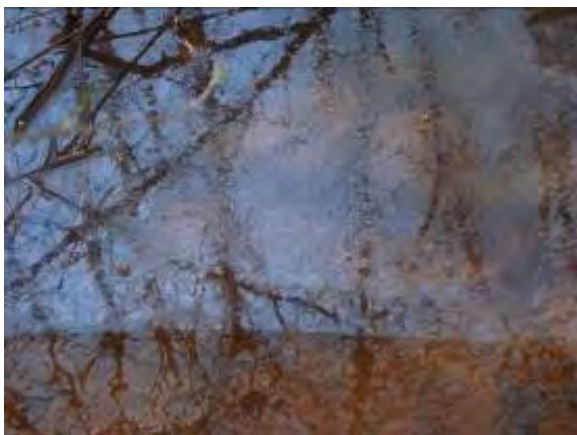
Storm drainage water near Evelina Drive, shiny surface

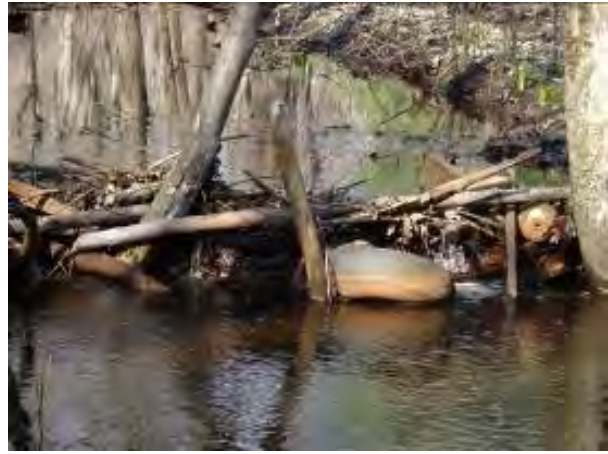
Little dam with debris

A small dam made of trash (tire and metal objects and small logs) was in the stream (D03).

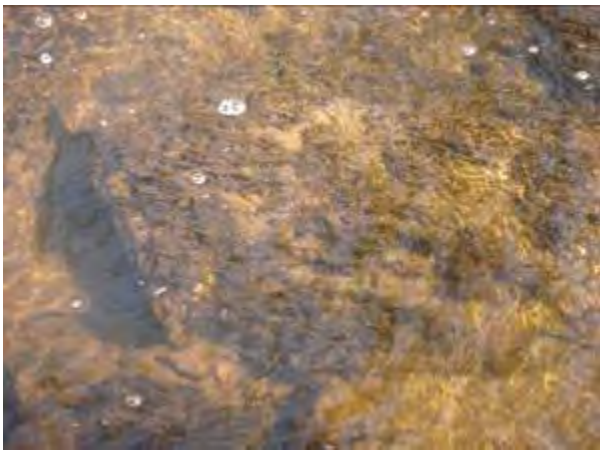
Algae or some sort of water plant 1-2 inches long and clinging to rocks underwater

Algae on underwater rocks was visible for several yards.

Investigate the algae.

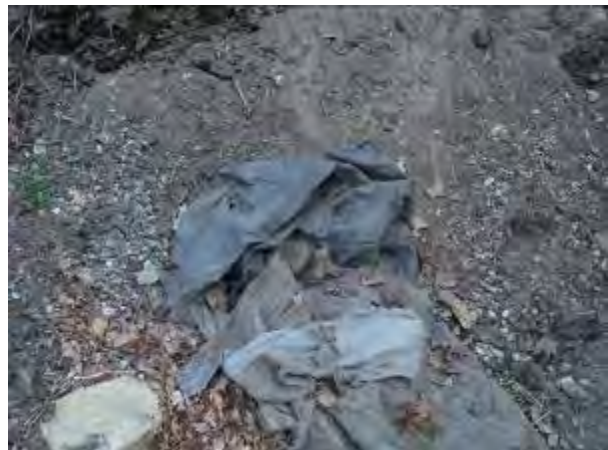
Debris pit near sand pit

At the sand pit, a large dirt and leaf dump nearby had trash mixed in. The source of the dirt/debris is unknown and is about 50 feet from the stream. It was a breezy day and dust/dirt was blowing around the sand pit. (F02)

Investigate the dirt/debris dumping and possible leaching near the sand pit (Map F02). Test the piles for pollution/toxins.

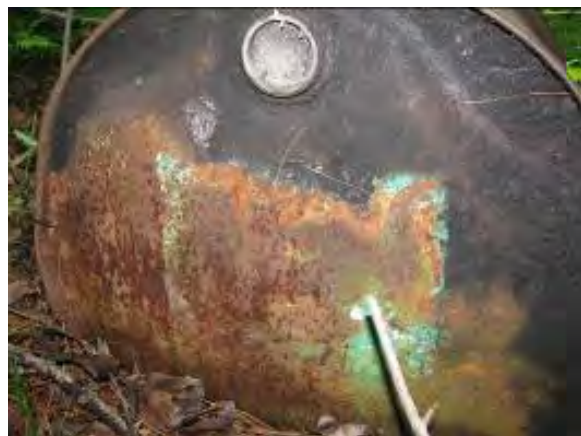
Abandoned barrel with unknown contents in the middle of B04 near stream bank

Large barrel with unknown contents in the middle of B04 on the east side of the stream near someone's backyard on Bigelow Street.

Inspect and remove barrel.

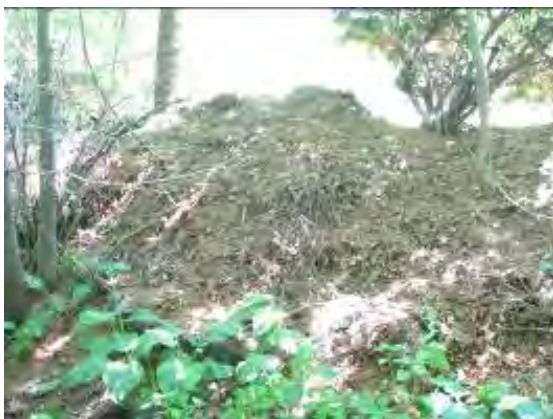
Grass clippings and lawn debris near stream

Yard waste dumped near stream. Grass clippings and other waste may have pesticides, fertilizers, and other waste.

Educate residents about the hazards of dumping along streams.

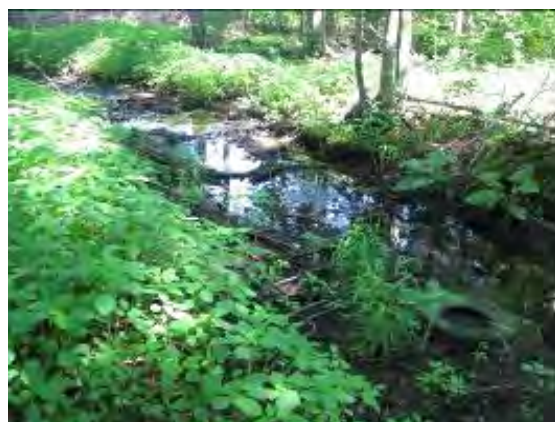
Streambed, tire, and backyard

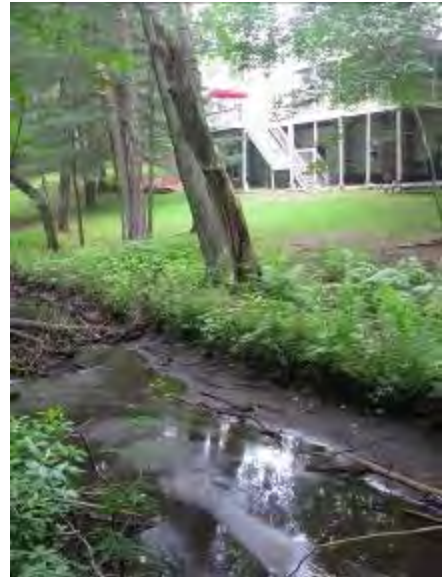
Development near stream, Jacobs Rd

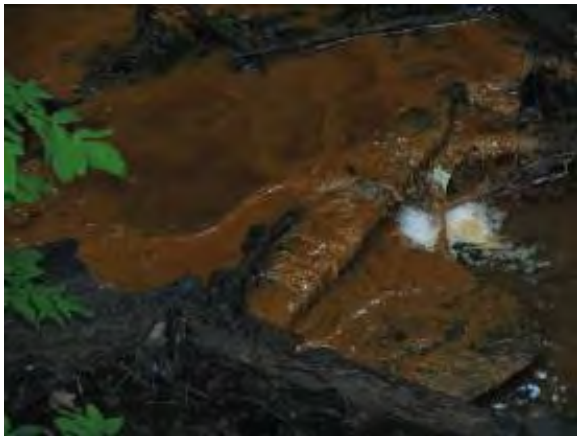
PROBLEMS: Development near streams and wetlands; red side-stream in D04?
ASSETS Wooded areas and wetlands
PRIORITIES Educating abutters about stream and watershed care

Red material in side-stream at D04 behind houses 52-52 and 52-51 on Ahlgren

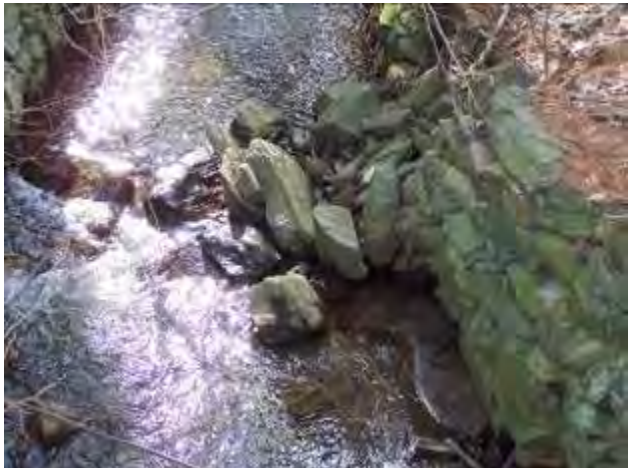
B1 Water near entrance to reservoir. Some rock bank collapse

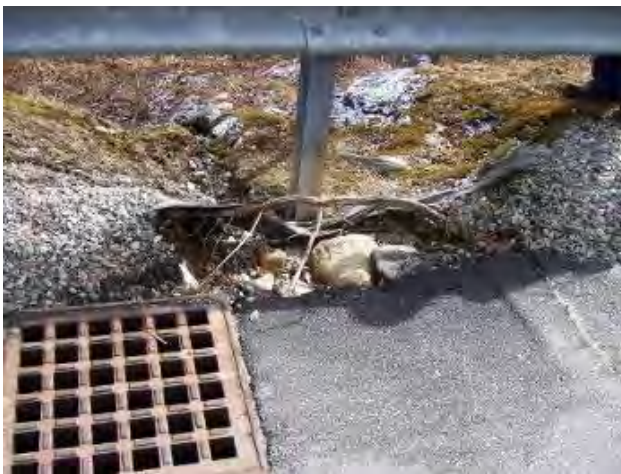
Damage near a storm drain

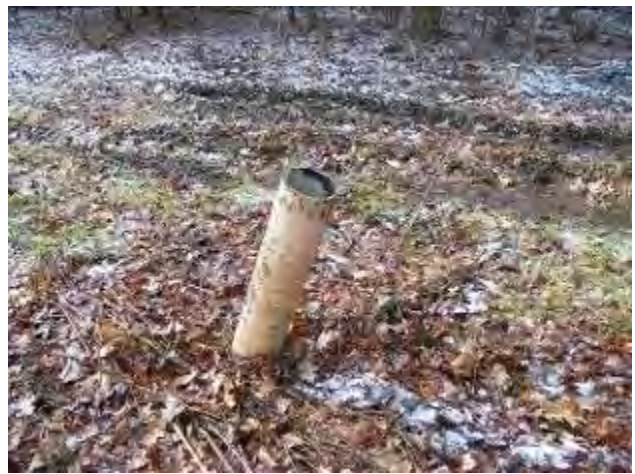
Uncapped pipe near Lake Williams

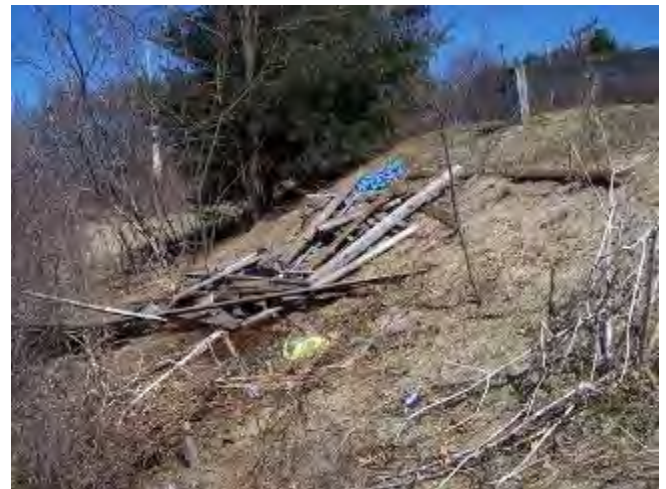
Debris dumped near stream

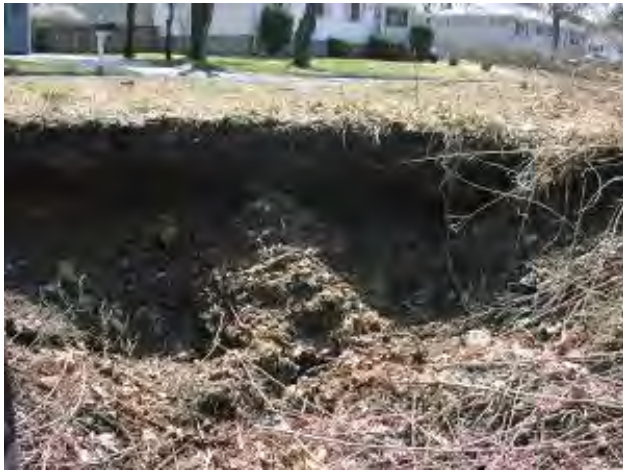
Erosion

Fix eroded bank

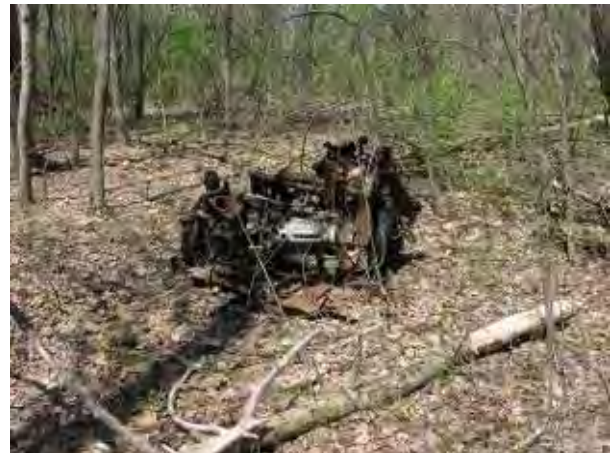
Abandoned debris
